**FINAL REPORT ON THE  
ENVIRONMENTAL TEST PROGRAM  
FOR THE  
ATMOSPHERE EXPLORER-B SPACECRAFT**

**SEPTEMBER 22, 1966**

**GODDARD SPACE FLIGHT CENTER**  
**GREENBELT, MARYLAND**

The AE-B spacecraft was launched May 25, 1966, from the Eastern Test Range (ETR) aboard a DSV-3c Delta launch vehicle (no. 38). Upon achieving orbit the spacecraft was renamed Explorer 32. Except for failures in the neutral particle mass spectrometer experiment and in the tape recorder, Explorer 32 continues to function well.

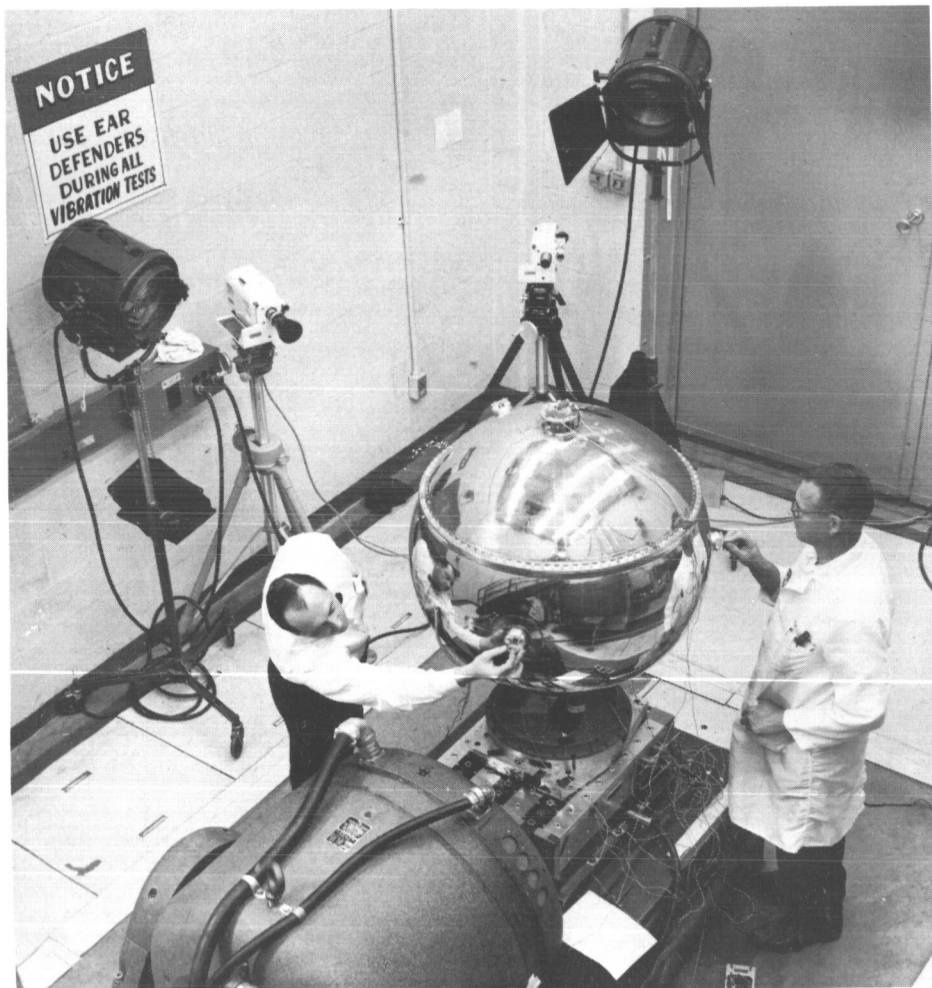
Figure 5—Shell no. 6 being readied for vibration tests in November 1964.

The test consisted of sinusoidal vibration in two perpendicular lateral directions from 30 to 8 cps at 1.5 g's. Two small bulges were detected at the base of the spacecraft after the first lateral test, and four additional small bulges were also detected after the second lateral test. The bulges were small shell areas which were permanently deformed during the test, indicating that the deformed metal was beyond the elastic limit; however, no cracks or ruptures of the metal occurred. A post-vibration leak test was conducted on the spacecraft November 6, and the resulting total corrected leak rate was  $1.7 \times 10^{-6}$  atm. cc/sec., which indicated that the shell structure had remained leak tight. Since no structural failure occurred and the shell remained leak tight, the spacecraft was considered to have successfully completed the vibration test. The fact that small areas of metal were permanently deformed was undesirable, but in this particular case the deformations did not constitute a failure. However, the test results indicated that the structure tested was marginal for the test conditions to which it was subjected.

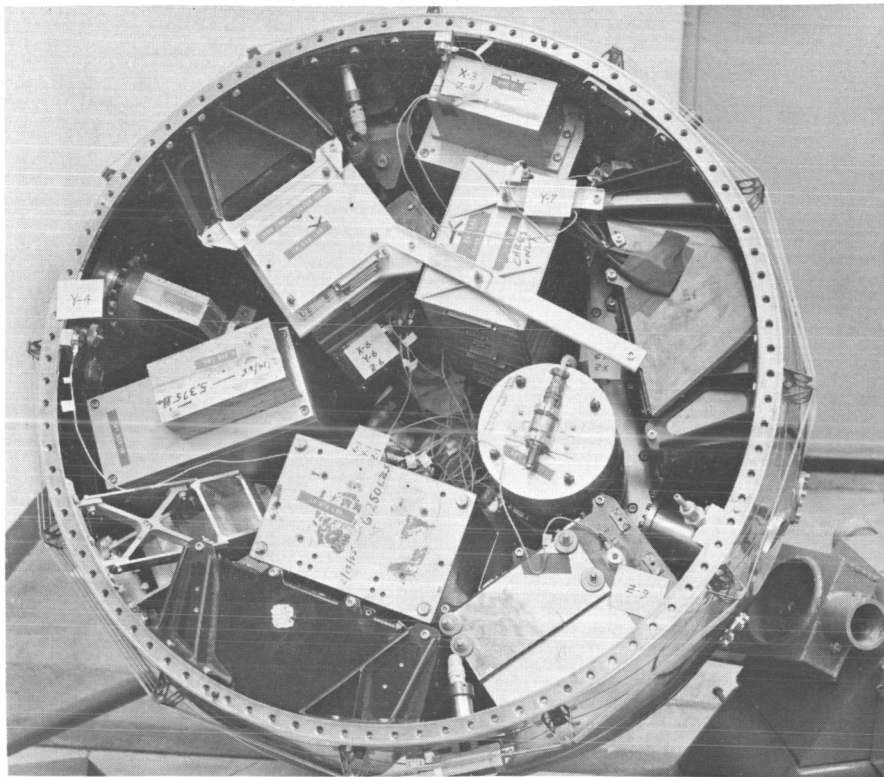
Figure 6—Shell no. 6 showing some of the accelerometer instrumentation for a vibration test in May 1965.

A pre-vibration leak test was conducted May 20, and the resulting total corrected leak rate was  $2.2 \times 10^{-7}$  atm. cc/sec. On May 24, 1965 shell no. 6, loaded to 480 pounds, was subjected to a vibration test in a lateral direction. The first step was a sinusoidal sweep from 500-5 cps at 0.5 g. A decision was made to remove the key in the clamp that was used to secure the spacecraft to

the attach fitting. During the test the spacecraft rotated about  $5^\circ$  in a clockwise direction as viewed from the top and at this point it was decided to install the key from the lightweight clamp in the heavyweight clamp with aluminum rivets. The second step was a sinusoidal sweep from 30–8 cps at 1.0 g. During the test the aluminum rivets were sheared and the shell skin was permanently deformed in two places near the base of the spacecraft. A post-test inspection revealed galled mating surfaces, improper mating of the spacecraft to the attach fitting, and indications of a large torque in the clockwise direction.

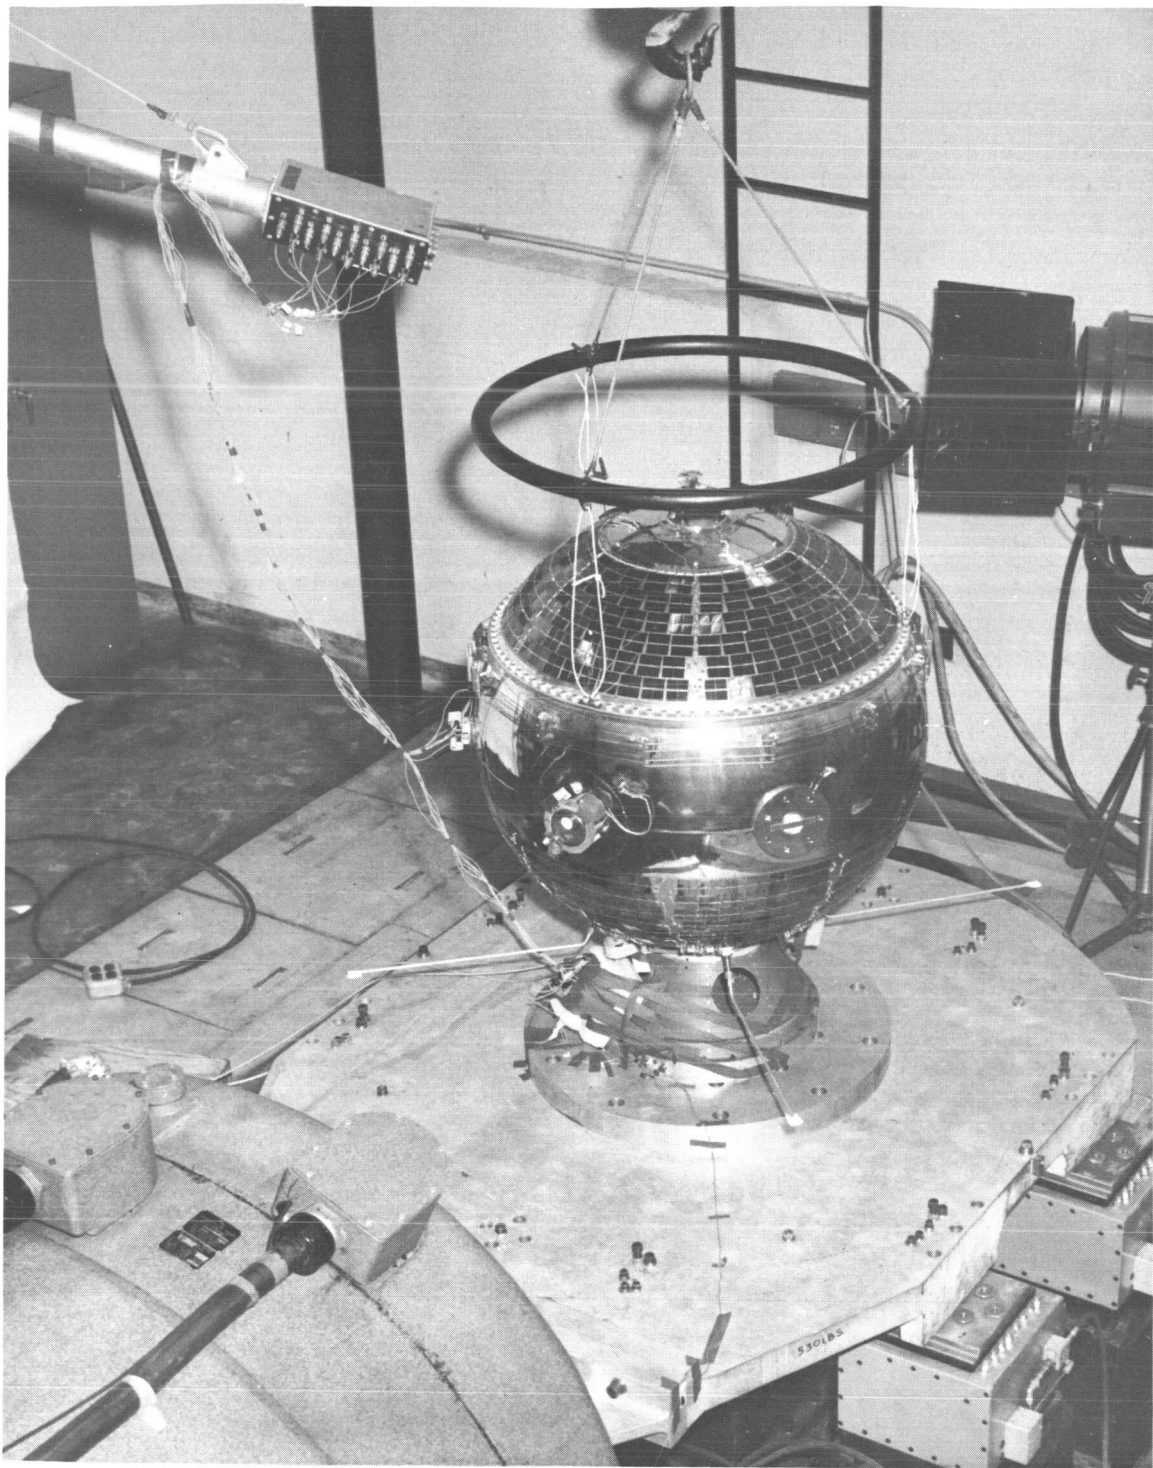
Figure 10—Flight spacecraft undergoing vibration test.

As a result of the test, two spacecraft problems developed; otherwise, the spacecraft successfully completed the test. After the first lateral axis test, the equatorial neutral particle mass spectrometer did not function properly. After completion of the test, the equatorial mass spectrometer data indicated further degradation. The second problem involved the stepper switch in the safety monitor subsystem which could not be commanded via telemetry after completion of

the test. The test results indicated that in both lateral directions the spacecraft resonance occurred at 14 cps.

During the thrust axis test, some mild "noise" was detected in the 15 to 10 cps range near the bottom of the spacecraft. This might have been caused by minute "gapping and banging" of the spacecraft base on the attach fitting or by parts internal to the spacecraft.

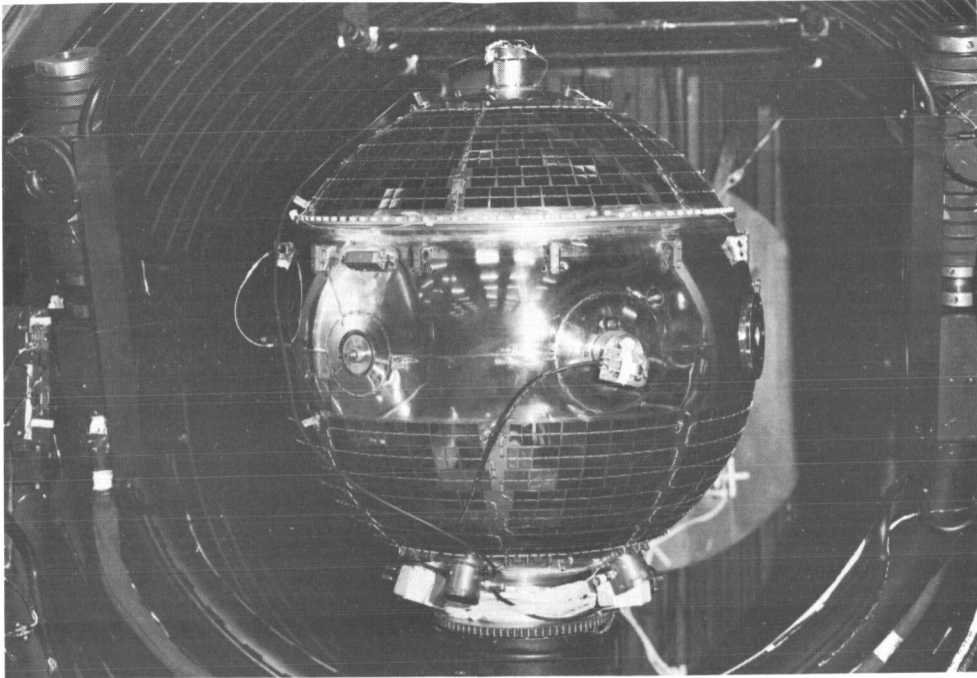
Figure 11—Flight spacecraft being readied for solar simulation test.

The solar simulation test was conducted during the period March 10-14, 1966 and was successfully completed except as noted below. The tape recorder in the spacecraft for the test was known to have a problem prior to the test. Parallel effort was directed toward resolving the problem while the solar simulation test was being conducted:

1. The tape recorder did not function properly.
2. The equatorial neutral particle mass spectrometer was disabled throughout the test and the mass spectrometer was replaced when the spacecraft was disassembled for installation of flight batteries and fuel cells.
3. The NRC pressure gage did not function properly.
4. Difficulty was experienced early in the test in (a) commanding the safety monitor subsystem from building no. 14, and (b) executing command nos. 26 and 28 (magnetic attitude control system). Difficulty was occasionally experienced with command no. 26 and other commands later in the test. Some of the real time data and playback data exhibited noise which was attributed to the chamber auxiliary drive motor. Some of the difficulty in commanding was also attributed to the auxiliary drive motor.

The chamber auxiliary drive motor functioned well during most of the test, but near the end the spin rate fluctuated down to zero. At this point the test was essentially completed.
